## Municipal Pool Selects DuraQuartz Lightweight & ENESEAL HR For Overhead Concrete Repairs

**Location:** Municipal pool located in eastern U.S.

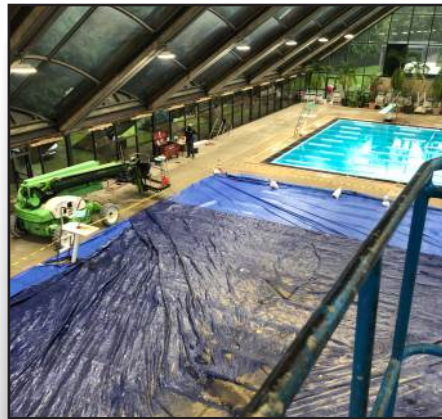
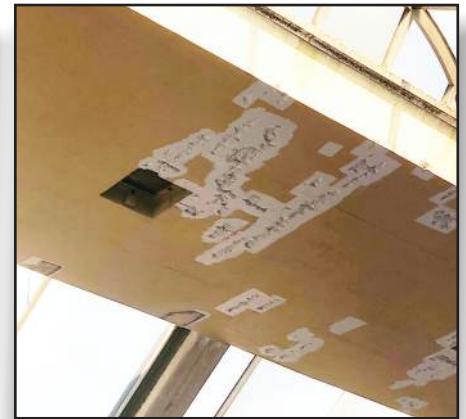
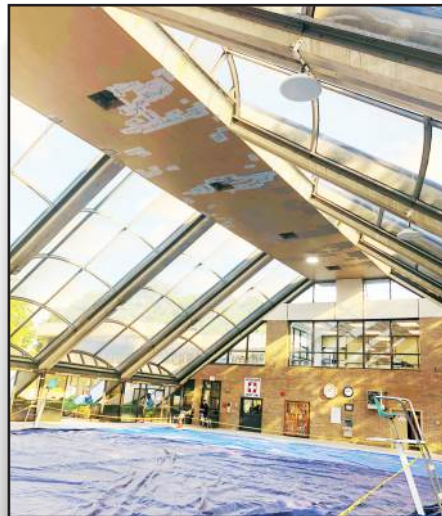
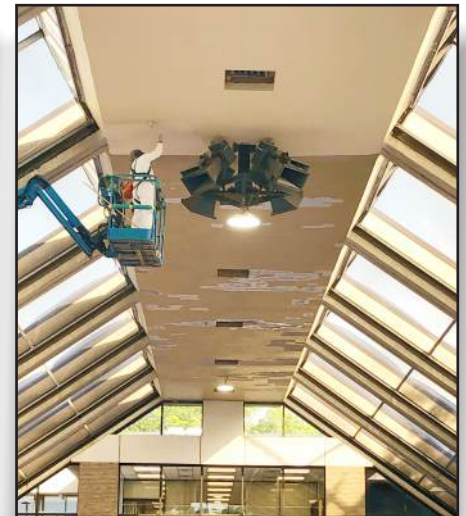
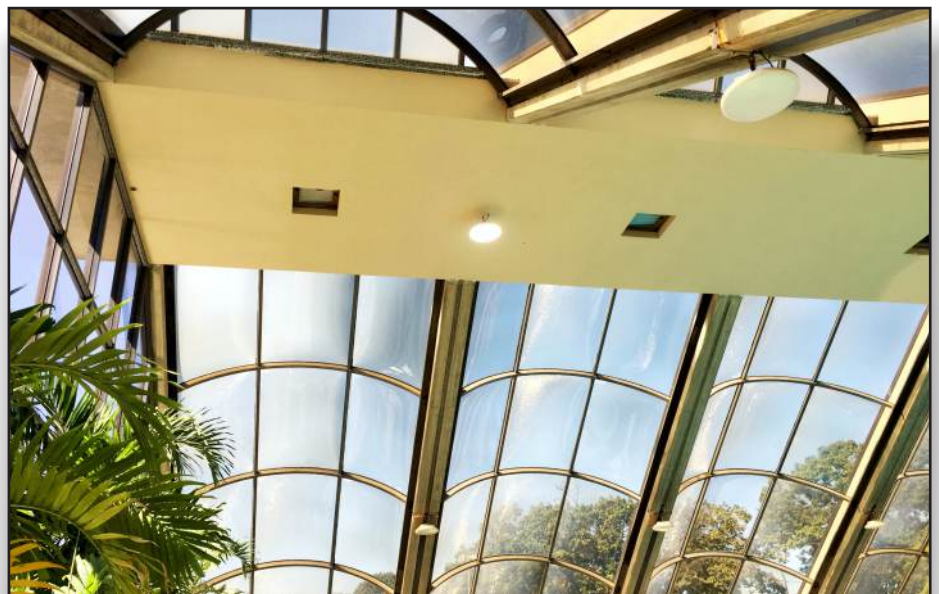
**Problem:** After years of leaking windows & skylights, the overhead concrete ceiling of this indoor pool building began to crack and spall. The potential for concrete chunks to fall into the pool while it was in use was a serious safety concern of the pool maintenance team.

**Solution:** The pool was first protected with tarps. Under the tarps were pieces of foam to prevent the tarps from sinking during the concrete preparation.

The concrete was prepared by manually chipping away any loose concrete near the cracks. The prepared areas were then primed and DuraQuartz LW was used to make the repairs. After the repairs were made two coats of ENESEAL HR were then applied.
