## Clarifier Tank Rim Repaired With DuraFill

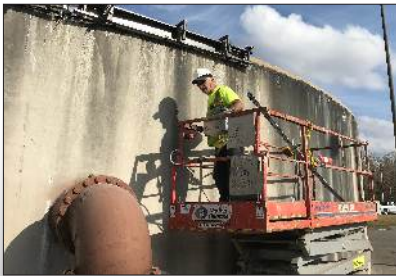
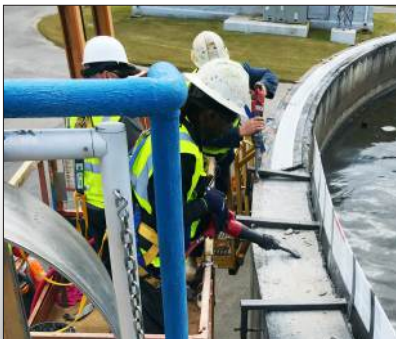
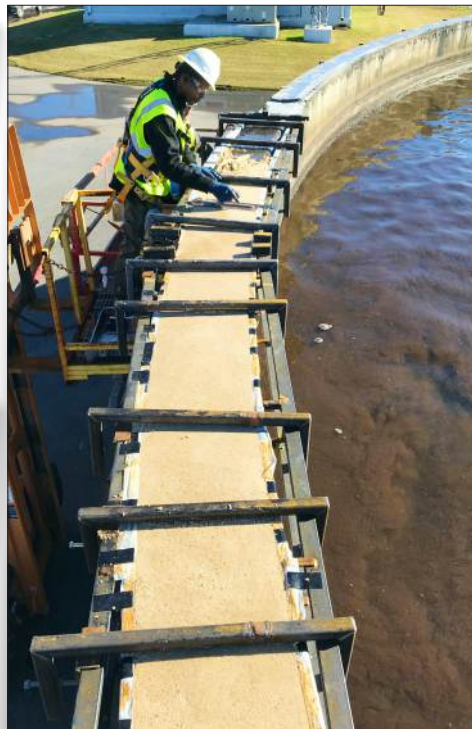
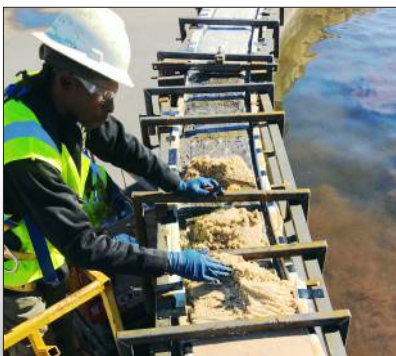
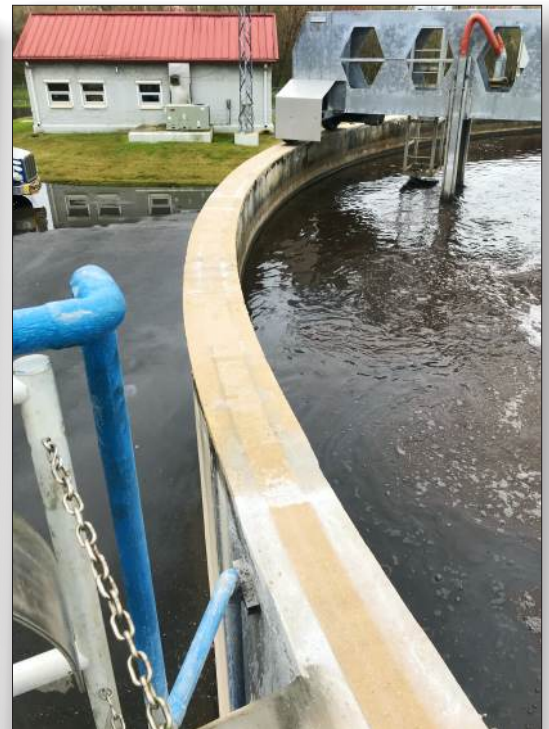
The steel plating on this clarifier tank rim, which serves as a track for the tank's scraping bridge wheels, had been in service for 15 years. Located at a Southern Louisiana wastewater treatment facility, the bridge makes approximately one full rotation every minute.

The plating weld seams began breaking causing the concrete underneath it to also break. The bridge wheels were being damaged as a result of the broken concrete.

cost effective solution. The plating was detached and any loose or crumbling concrete was removed using an air chisel hammer. A former was constructed and clamped to the tank rim to prevent concrete from falling into the tank.

DuraFill was mixed with a locally sourced silica quartz sand and applied to the tank's rim. The former also allowed the applicators to keep the DuraFill level during application. The entire project only used 5 units of DuraFill, but it saved the maintenance team at the plant tens-of-thousands of dollars.
