## Popular Cocktail Bar In Cyprus Uses ENECRETE DuraFill To Repair Crumbling Floor

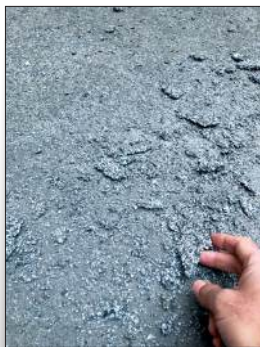
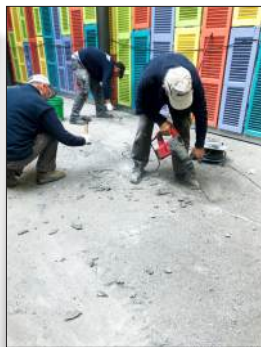
All the loose flooring material is removed

The flooring material at this cocktail bar in Cyprus was deteriorating and coming loose. This was both unsightly and a potential tripping hazard. The bar's owners needed to find a quick and effective solution to solve this problem.

The existing, failing flooring material was removed and the

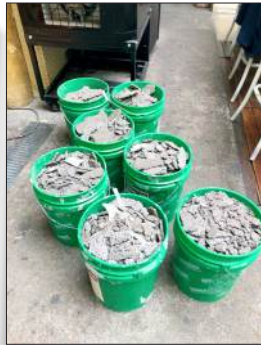
The substrate is prepared

concrete substrate was cleaned and left to dry. **ENECRETE DuraFill** was applied by brush and roller to the concrete as a primer. The owners had chosen a decorative stone that was mixed with the *DuraFill* and applied to the floor. Once this step of the application was completed, a layer of *DuraFill* resins was rolled onto the floor to seal it and provide maximum protection.

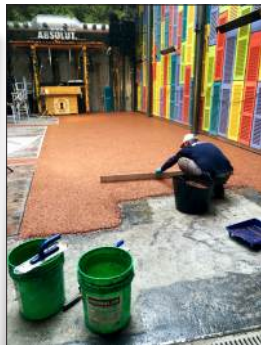
DuraFill and decorative stone is applied
