## Russian Fire Station Floor Repaired With DuraQuartz & Protected With ENECLAD FPS

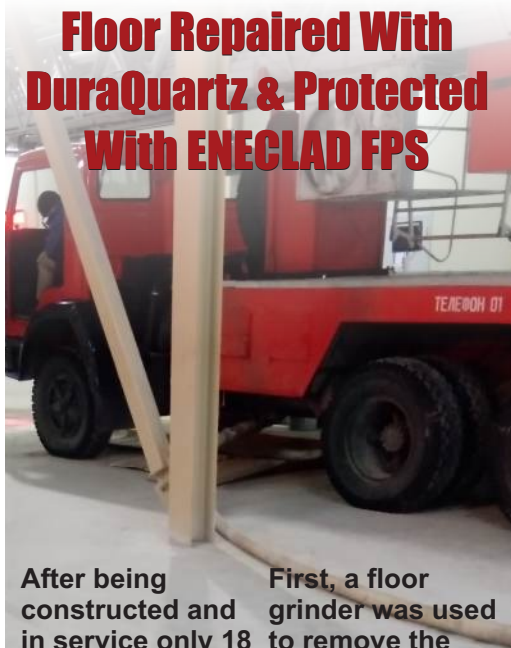
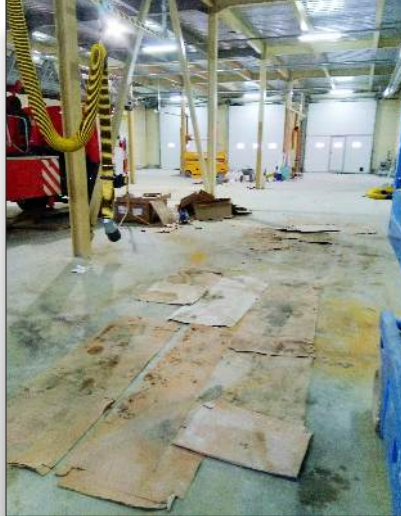
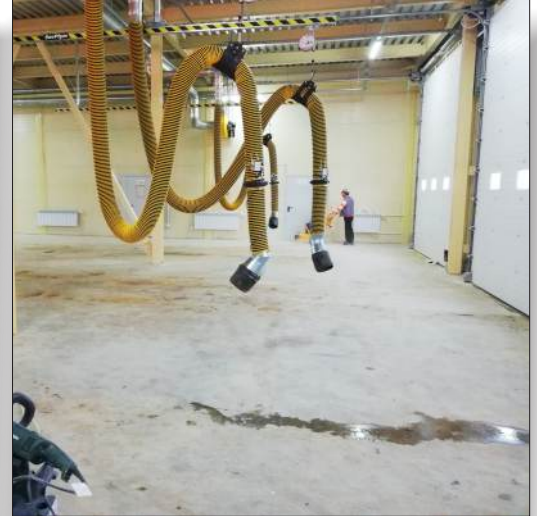
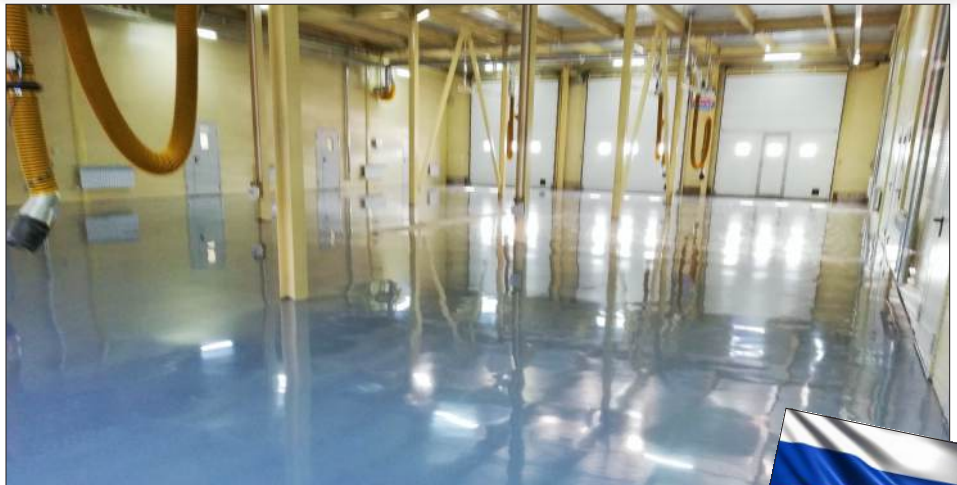
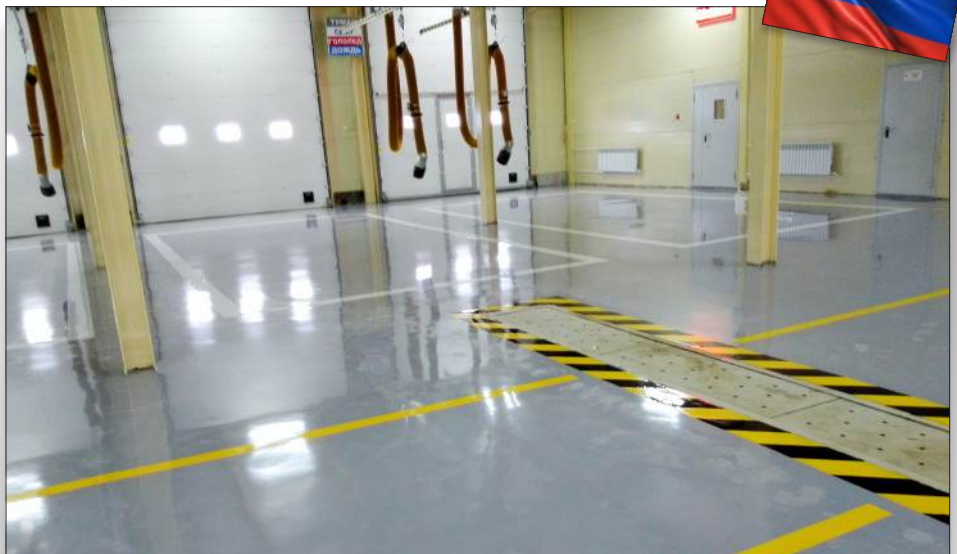
After being constructed and in service only 18 months, the protective coating on the floor of this Russian fire station failed. The concrete was absorbing oil and other liquids. The station operator needed a fast, durable and affordable solution.

The ENECON Distributor in Russia was contacted and proposed a complete resurfacing of the entire 5,800 sq. ft. floor.

First, a floor grinder was used to remove the failed, existing coating. Any necessary repairs to the concrete were made with DuraQuartz, then the entire floor was primed with ENECLAD CFS.

Two coats of ENECLAD FPS in Haze Gray were applied to the entire surface. To complete the intricate striping patterns needed in the fire station, a combination of CHEMCLAD GP in Safety Yellow and CHEMCLAD XC in White and Dark Gray were used.
