Seattle Office Building Steps Repaired & Protected With ENECRETE

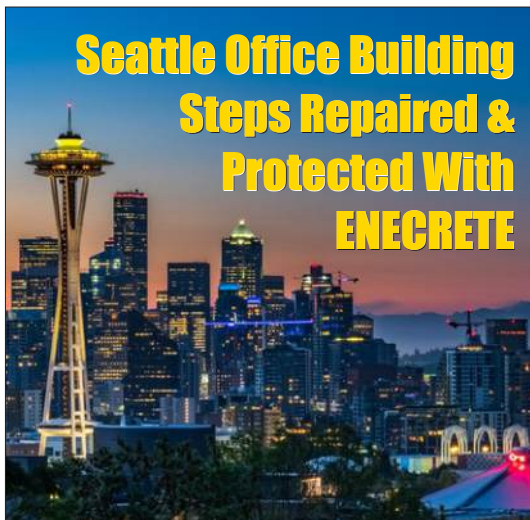
These outdoor courtyard steps in Seattle, WA have heavy foot traffic all day long from general sidewalk use and office building/restaurant entry ways in the courtyard. Over the past decade, the condition of these steps has deteriorated with cracks and concrete loss.

The steps were first pressure washed to remove years of dirt and debris. Next the cracks were "V-ground" to remove loose material.

DuraQuartz was then applied to fill and smooth all the cracks. Several other areas required larger DuraQuartz repairs to fill large holes, a lengthy crack on a riser and replace and secure several broken and loose pieces much like a jigsaw puzzle.

Finally, two coats of DuraFill and a blended colored quartz aggregate were applied in the typical broadcast fashion.
