CeramAlloy CBX Protects Newly Fabricated FPSO Caisson From Internal Abrasion Damage In Australia

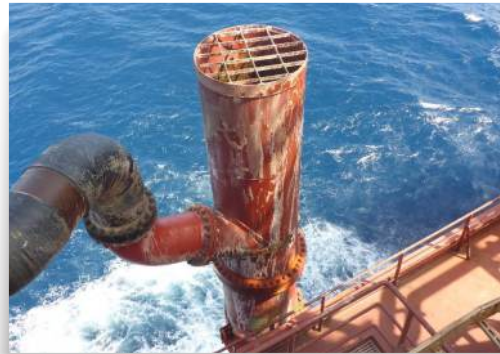
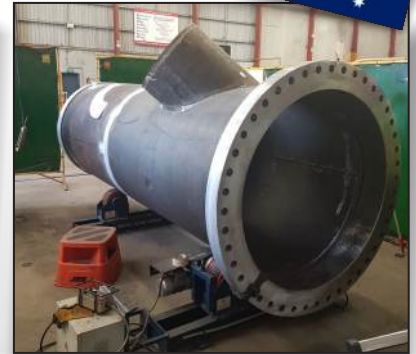
The seawater travels at a high velocity and the particulates in it cause erosion due to abrasion. Once these abrasion problems exist, the caisson begins to become ineffective.

It was decided that a newly fabricated caisson would be installed and before installation it would be protected from internal abrasion with CeramAlloy CBX.

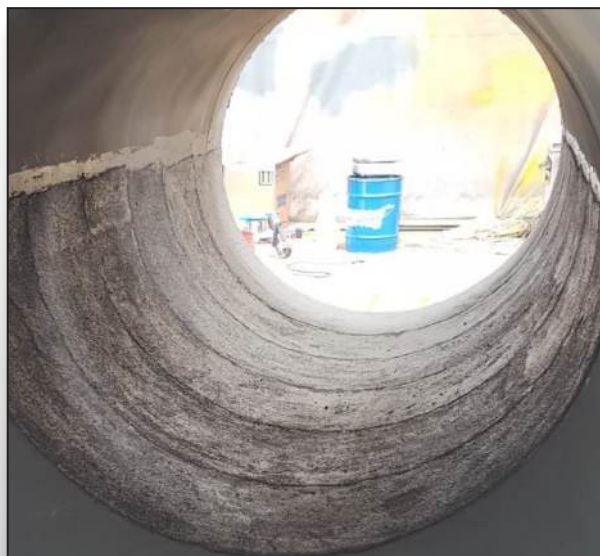
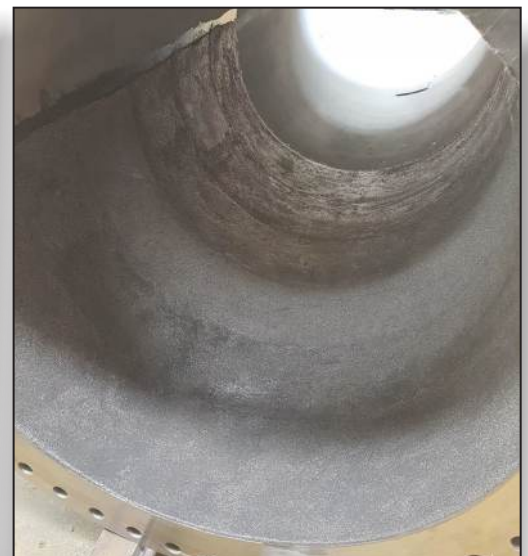
The caisson was first abrasive blasted then primed with CeramAlloy CL+AC. The CeramAlloy CBX was then applied at an average of 5mm thick. The FPSO operator was extremely pleased with the performance results of this CBX application.
